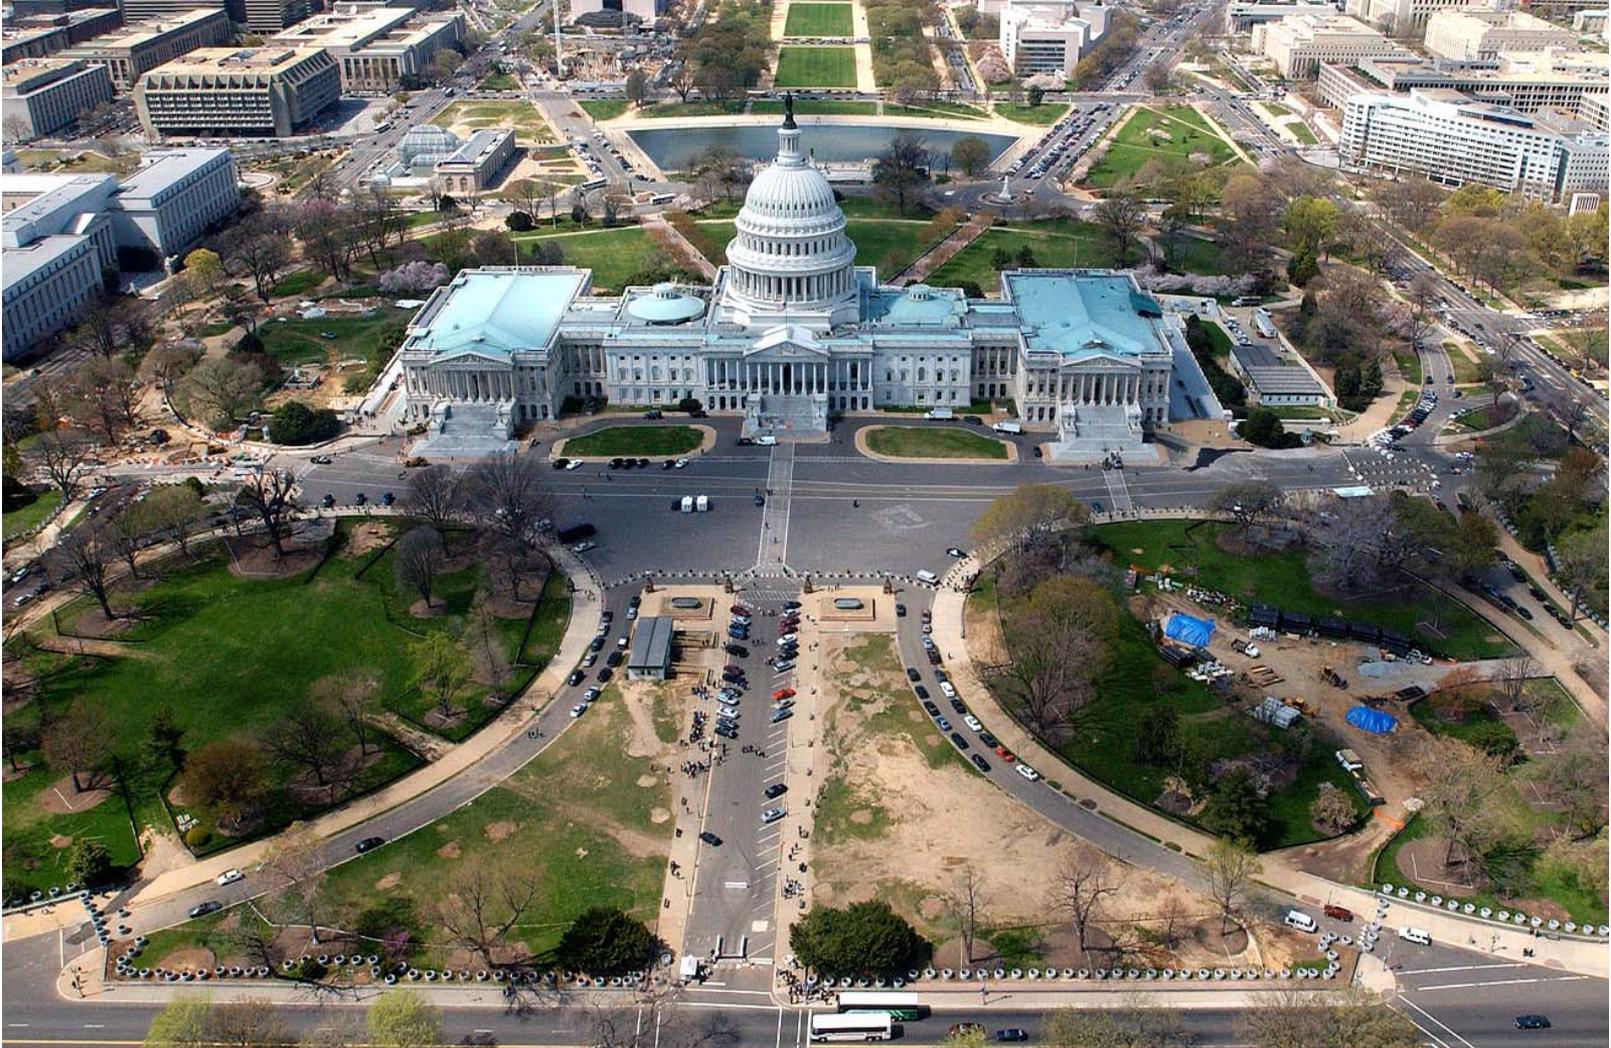
April 2, 2002

In April, 2002, before any major construction began on the East Capitol Grounds, a tree preservation plan was being implemented and included installation of tree protection fencing, a new irrigation system, and a canopy mist system (to keep construction dust off of leaves), pruning, mulching, and relocation of eight memorial trees. Approximately 65 trees had to be removed, mostly from the central triangular zones (center of photo), to clear the project footprint for excavation. More than 85 new trees will be planted after construction to re-establish the grand views and park-like setting designed by landscape architect Frederick Law Olmsted in 1874. A visitor screening facility just south of the Capitol (just left of Capitol in this photo) was being constructed during this time. Meanwhile, an extensive effort to relocate existing utilities was ongoing.

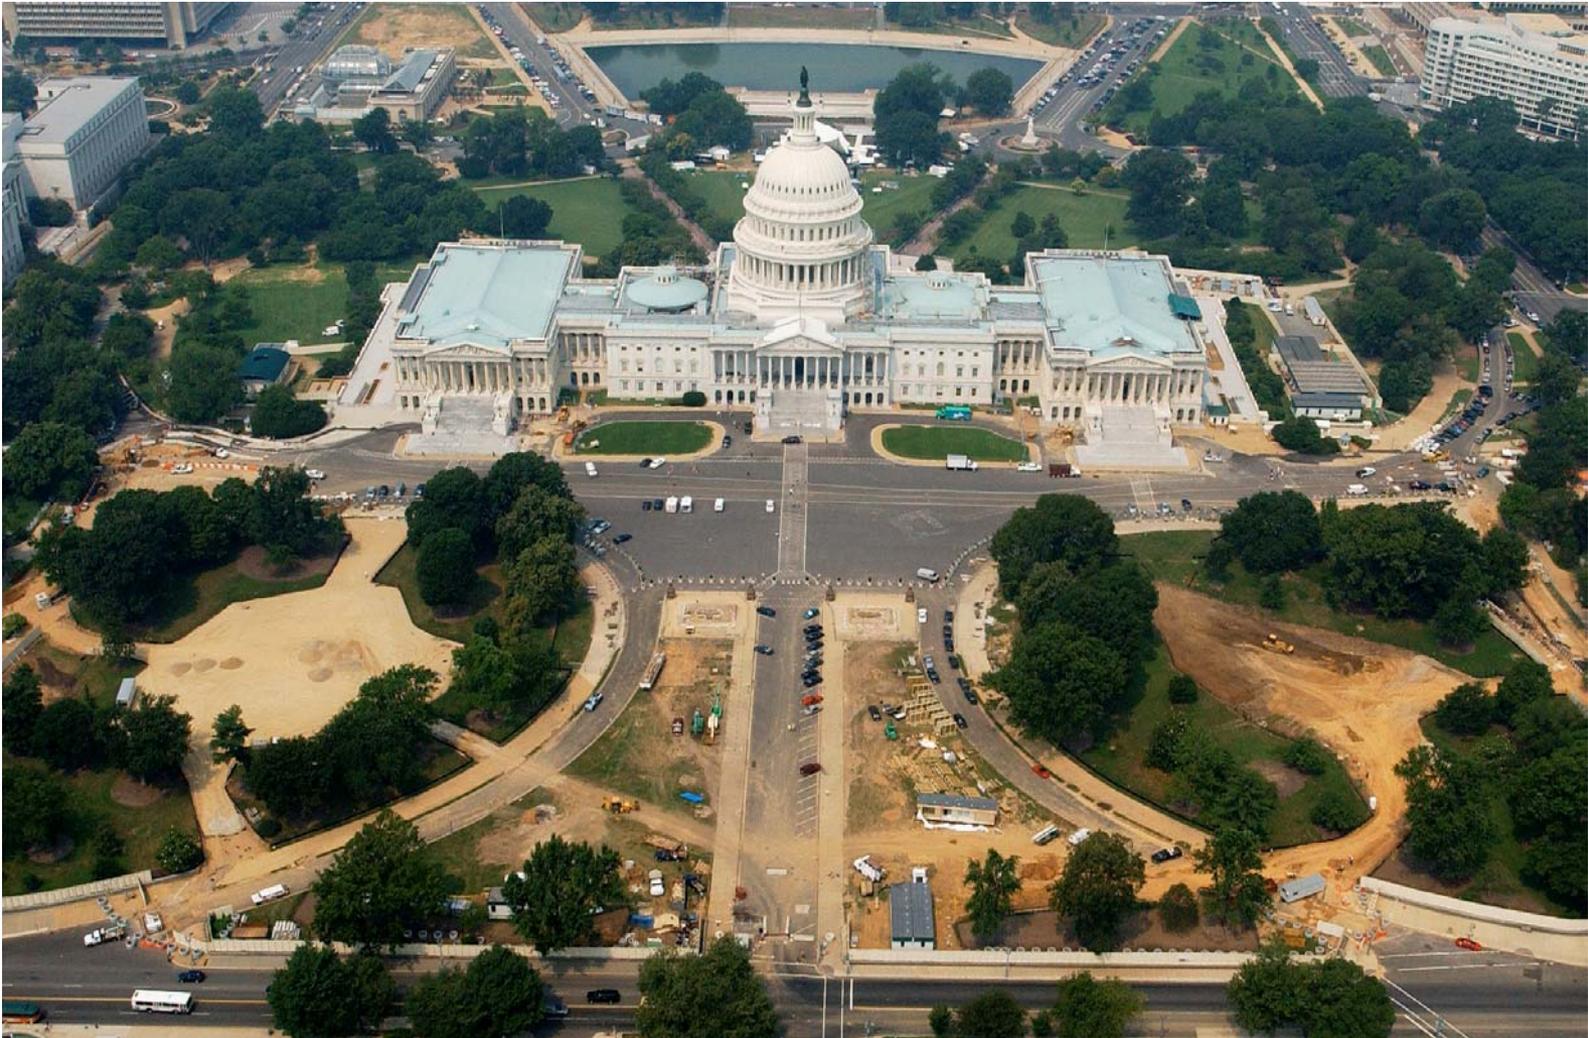
July 2, 2002

Once the tree preservation program was in full implementation, the grassy areas within the north and south oval areas (left, right) were leveled to establish a suitable area for staging of construction trailers and equipment. Utility removal continued during this period and installation of noise reduction windows was ongoing. The visitor screening facility on the south side of the Capitol was completed and a smaller screening facility was also constructed on the north side of the Capitol to screening visitors to the Senate Gallery.

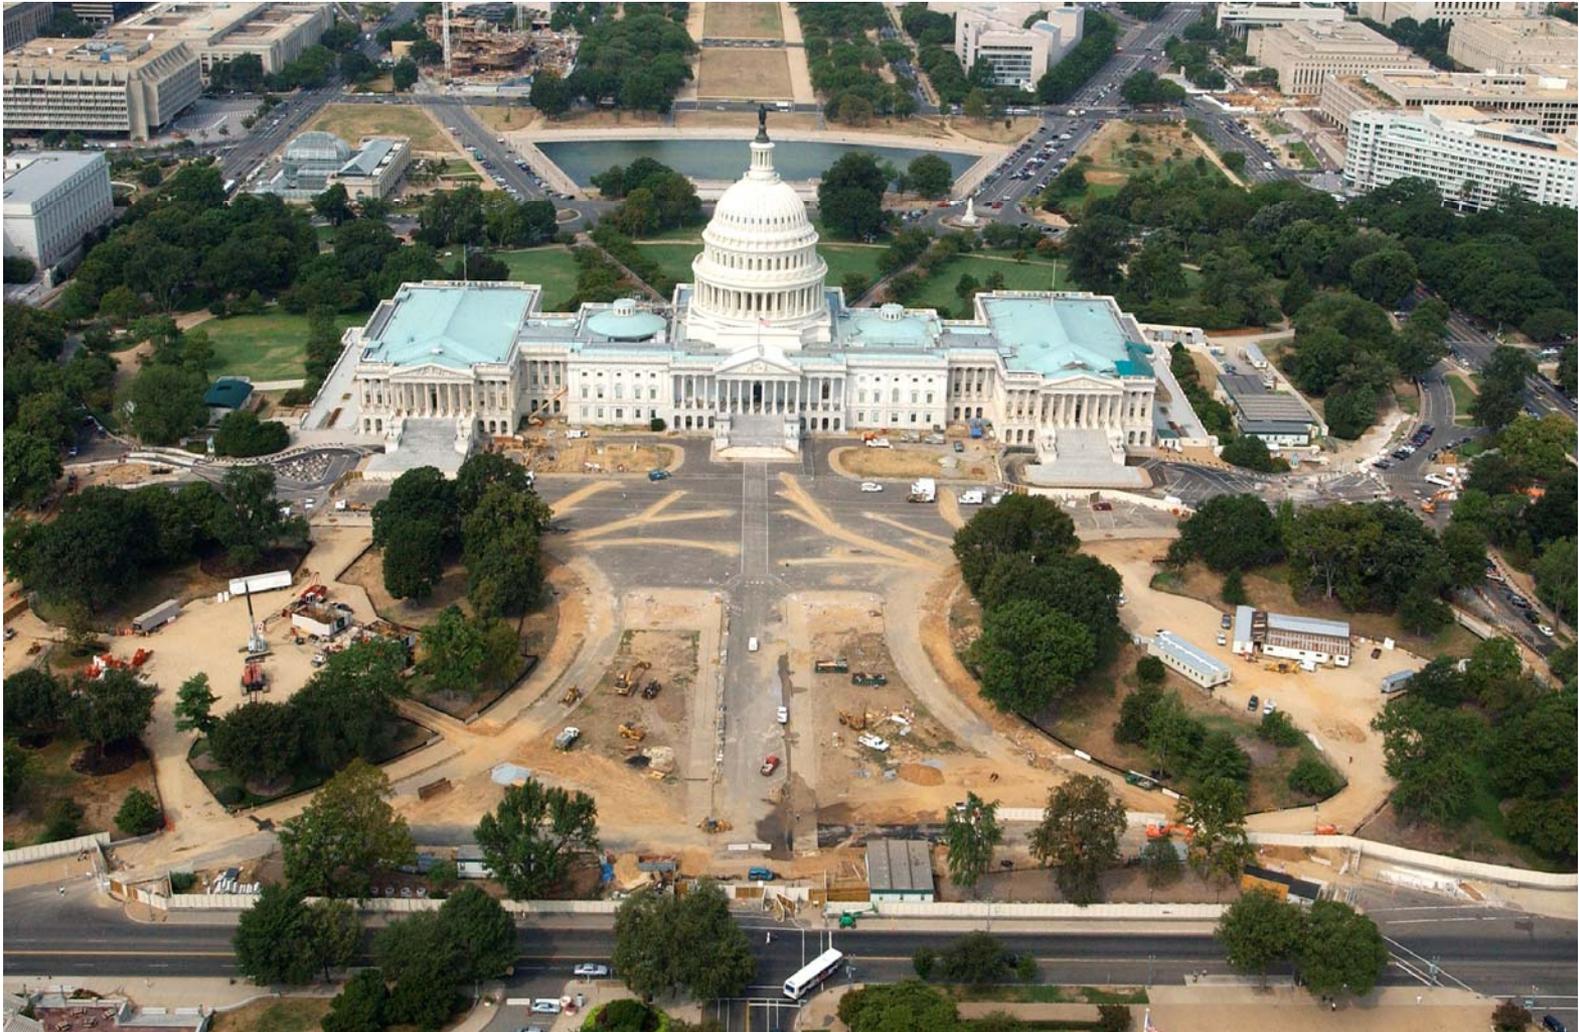
August 22, 2002

In August 2002, construction trailers and equipment could be seen within the grassy oval areas (left, right) and along First Street (foreground). Installation of noise reduction window units along the East Front was nearing completion and close to 300 parking spaces lost to construction had been successfully offset by establishing new spaces near the House and Senate Steps, in Upper Senate Park, and along Northwest and Southwest Drives. Utility relocation work was ongoing and excavation activities were just beginning across the East Plaza. Alternate media sites, previously located in the grassy ovals on the north and south sides of the site, were relocated to the Cannon Terrace and Upper Senate Park.

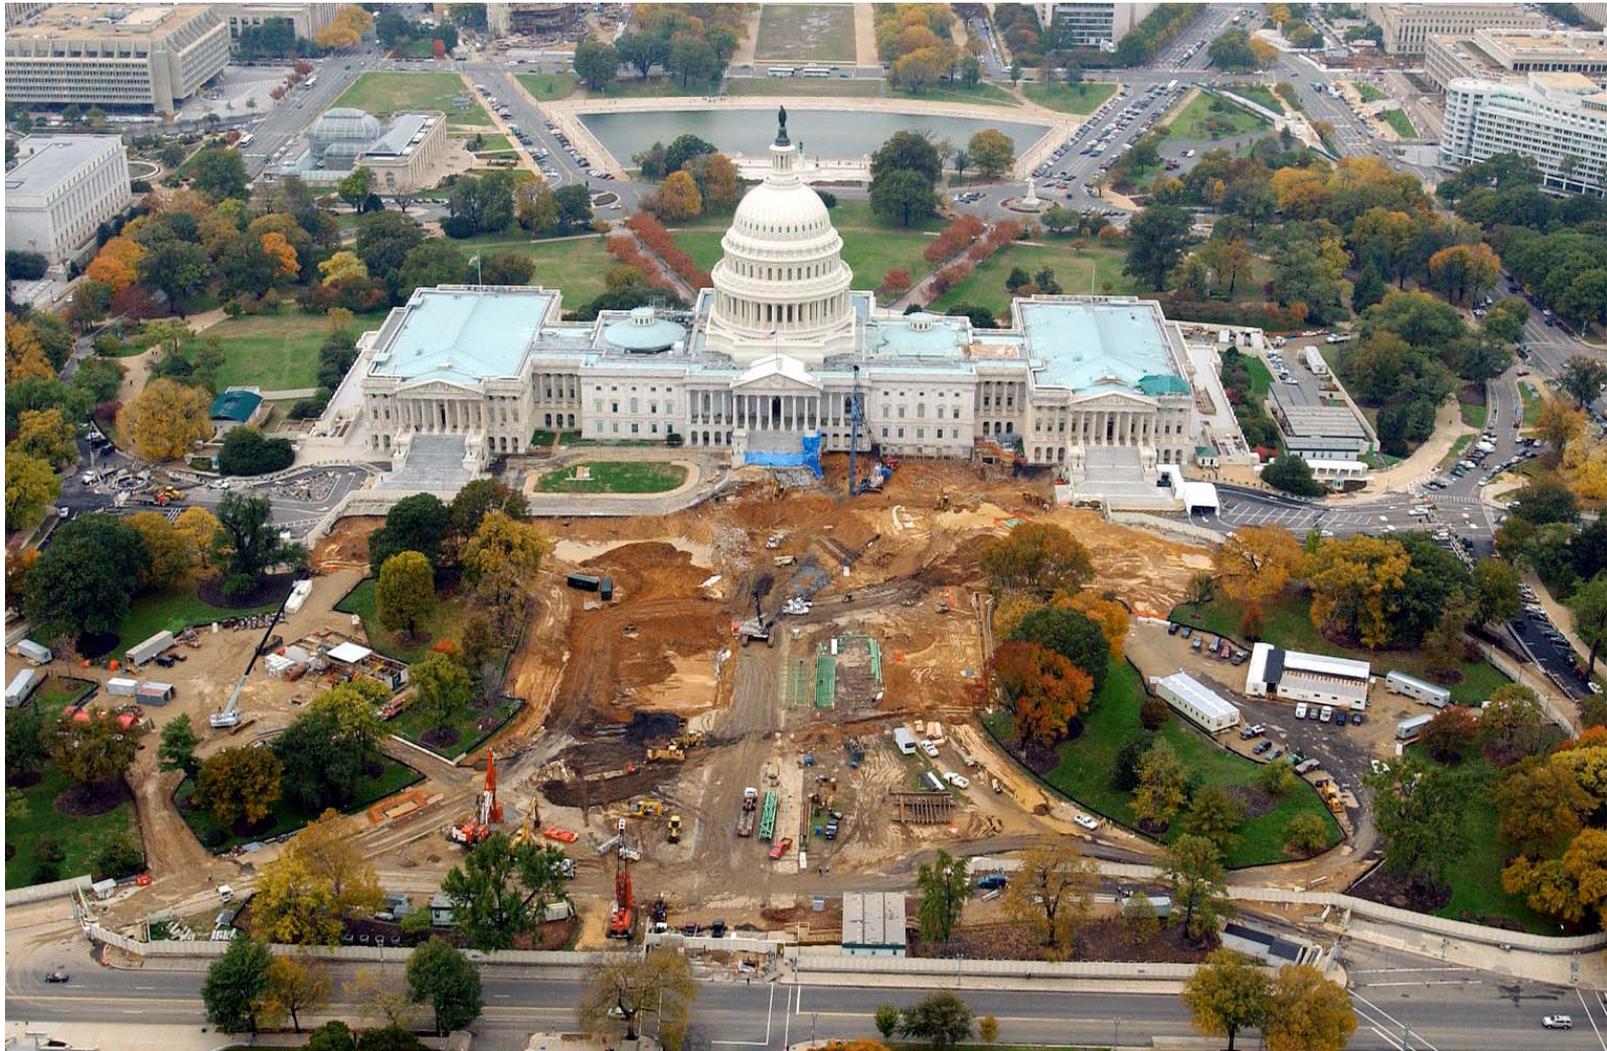
October 31, 2002

In October 2002, just two months after excavation began, the project footprint began to emerge. More trailers, equipment and materials could be seen throughout the project site. Red “clamshell” rigs can be seen in the foreground (left of center) as they were poised to begin construction of the perimeter wall of the CVC. The CVC footprint, at 193,000 sq. ft., is larger than the footprint of the Capitol itself.

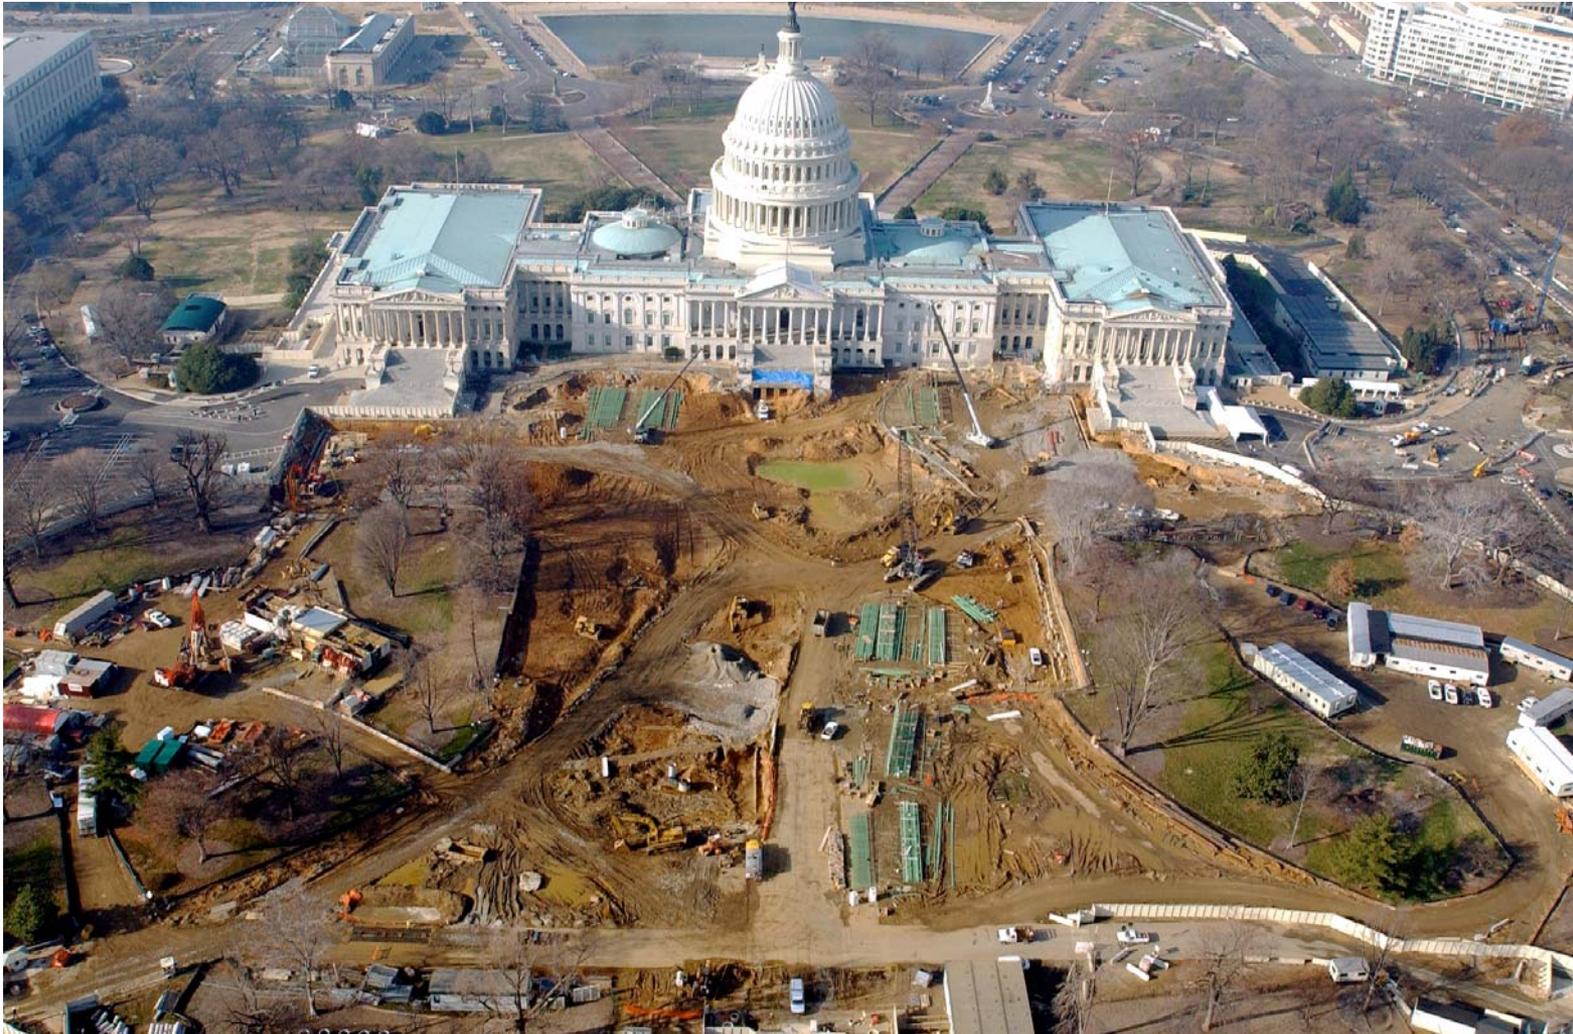
December 31, 2002

In December 2002, with foliage gone, the project footprint comes more clearly into view. Also visible in the center of the photo is one of several drainage ponds that helped to divert water from construction zones. The persistent rain throughout the fall and winter began to slow the pace of excavation activities. Green rebar cages for the perimeter wall panels can be seen being assembled in the center of the site and near the Capitol along the House side. Work on the truck tunnel on the north side of the site (far right) can be seen along Constitution Avenue. Perimeter (“slurry”) wall construction was underway in front of the House Steps in the southwest quadrant of the site.

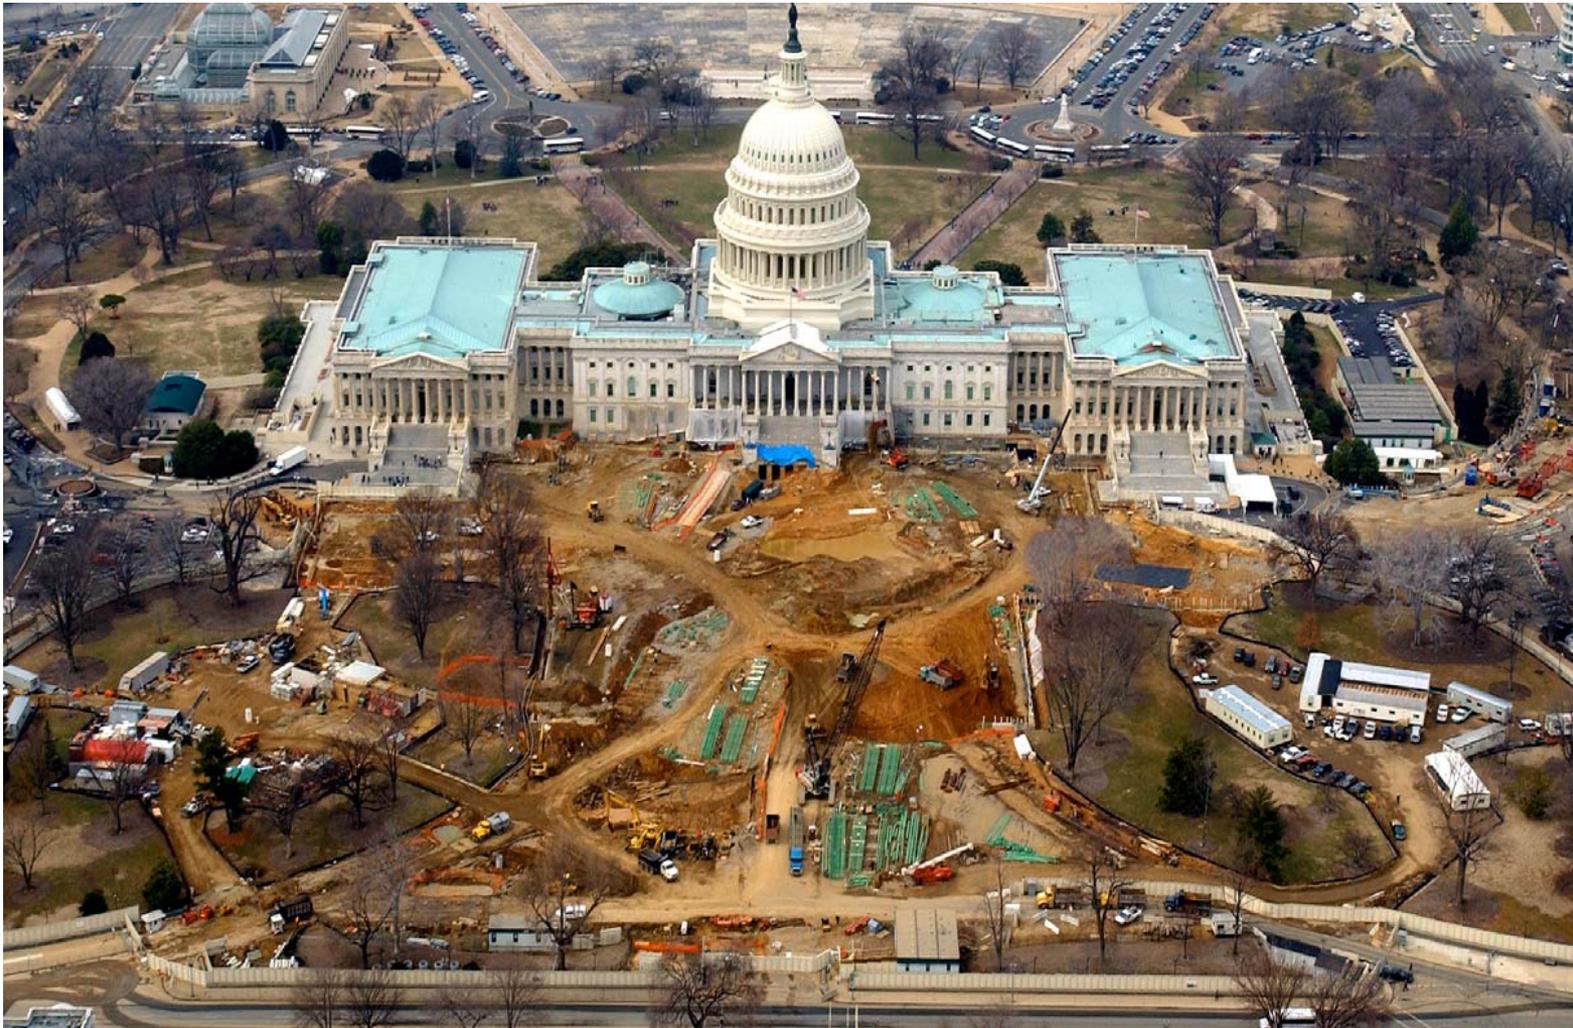
March 12, 2003

As spring approached, record amounts of rainfall continued to impede construction progress and a large drainage area, visible in December 2002, can still be seen in the center of the photo. Construction activity continues throughout the site. Work on a connector tunnel to the existing Cannon Tunnel can be seen just south of the House Steps.

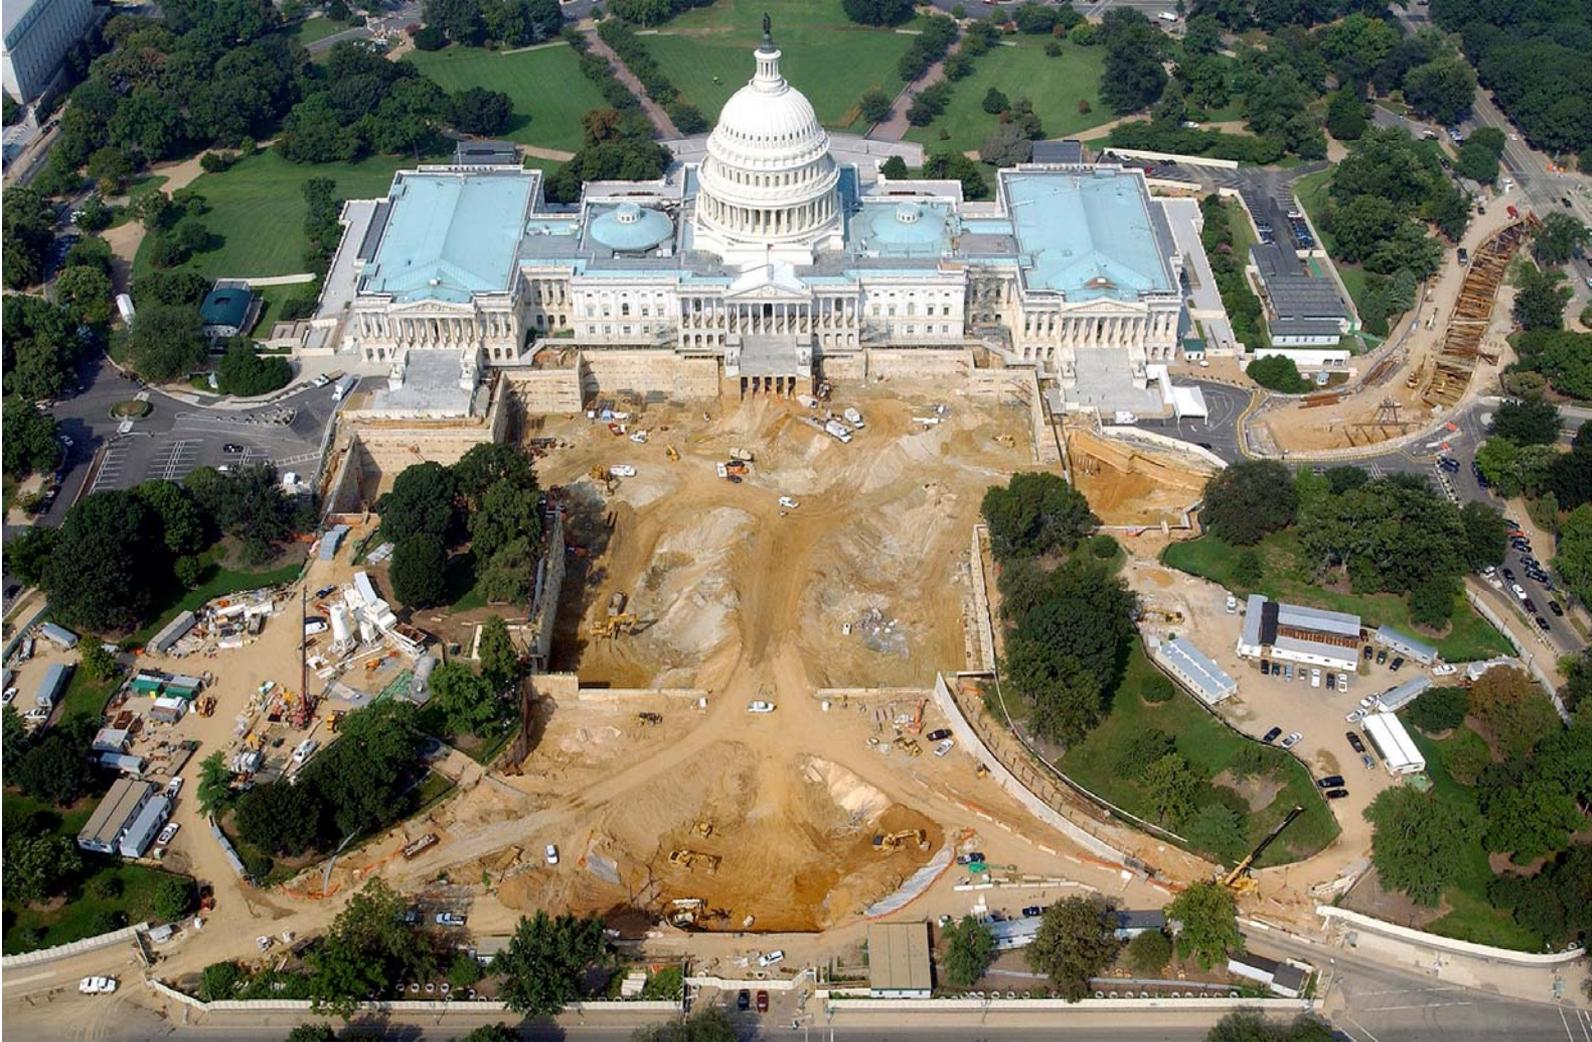
August 14, 2003

After persistent rain throughout the spring and summer had forced the postponement of five helicopter flyovers, AOC photographers finally got the opportunity to fly in August 2003. By this time, the project footprint was clearly defined, the perimeter wall complete, and excavation more than 60% complete. Over 300,000 cubic yards of material (more than 30,000 truckloads) had been removed from the site. Excavation for the Congressional Auditorium (foreground center) was underway and crews had completed initial structural support work for the truck tunnel on the north side of the Capitol (top right). The empty parking lots on both sides of the Capitol are a clear indication that Members were still on recess.

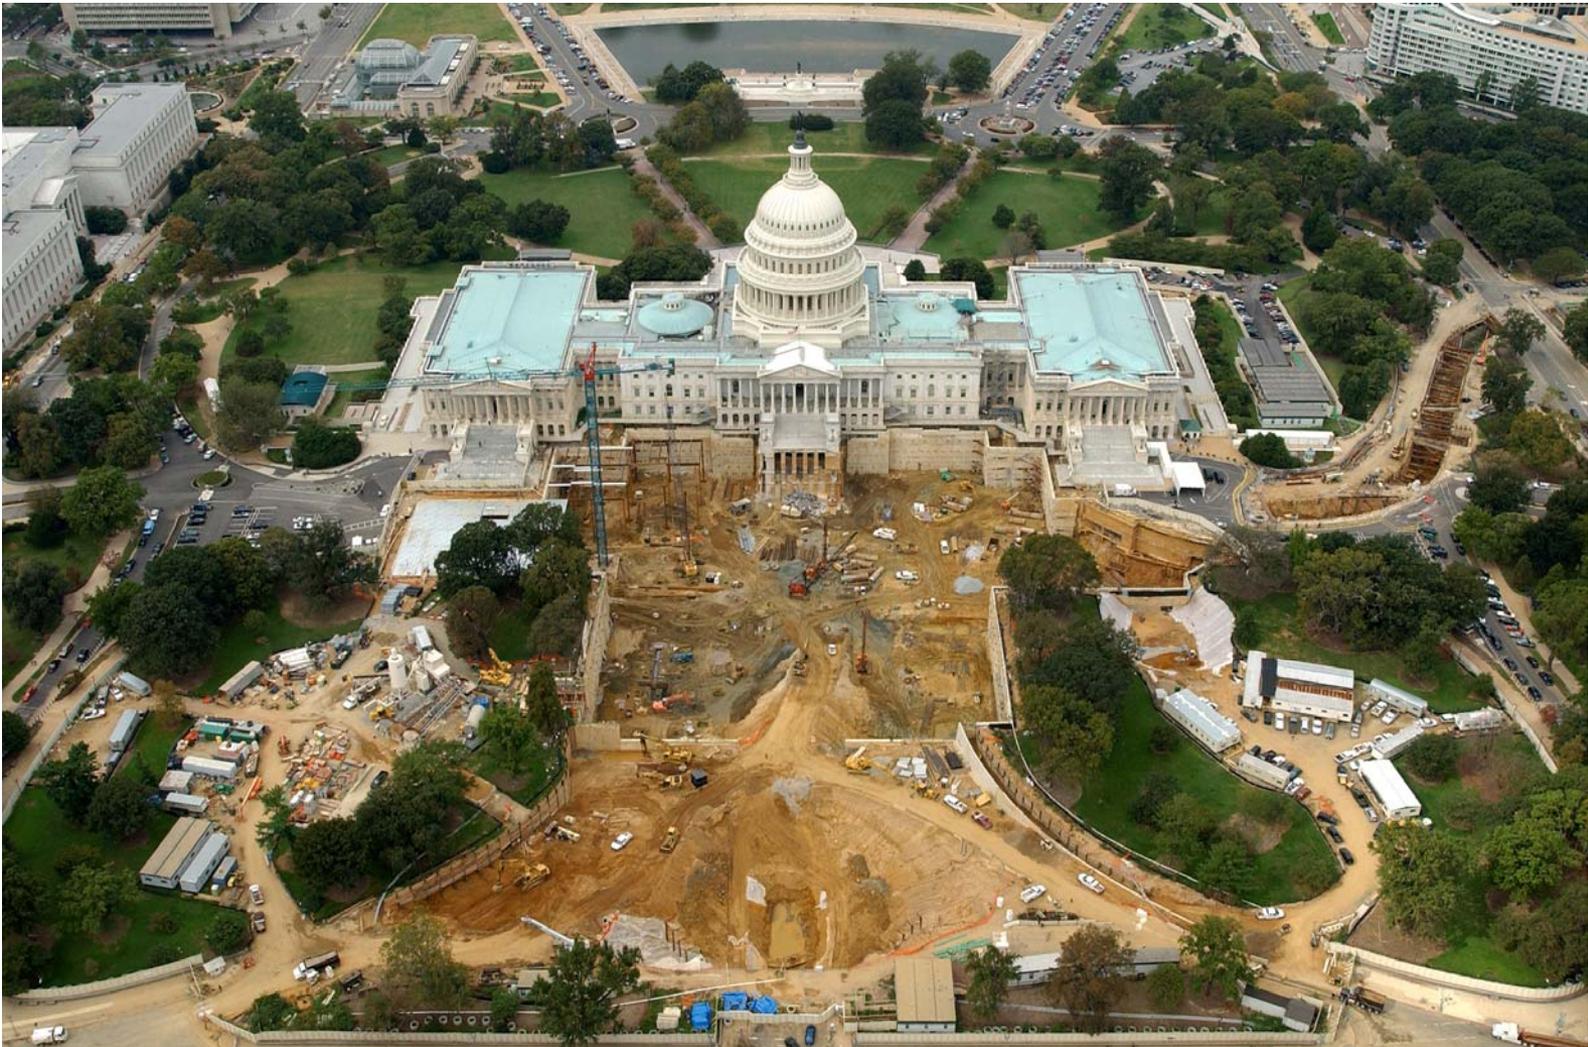
October 10, 2003

By October 2003, excavation was nearly complete and steel had been erected in the southwest quadrant of the site (center left). The first steel column had been raised on September 5, 2003. Corrugated steel roof decking can also be seen in front of the House Steps and a 300-foot-high tower crane punctuated the high level of construction activity that occurred in October. The gently sloping pedestrian paths leading from First Street NE/NW (foreground) had begun to be defined. The south oval area (left) was densely packed with trailers, equipment and materials.

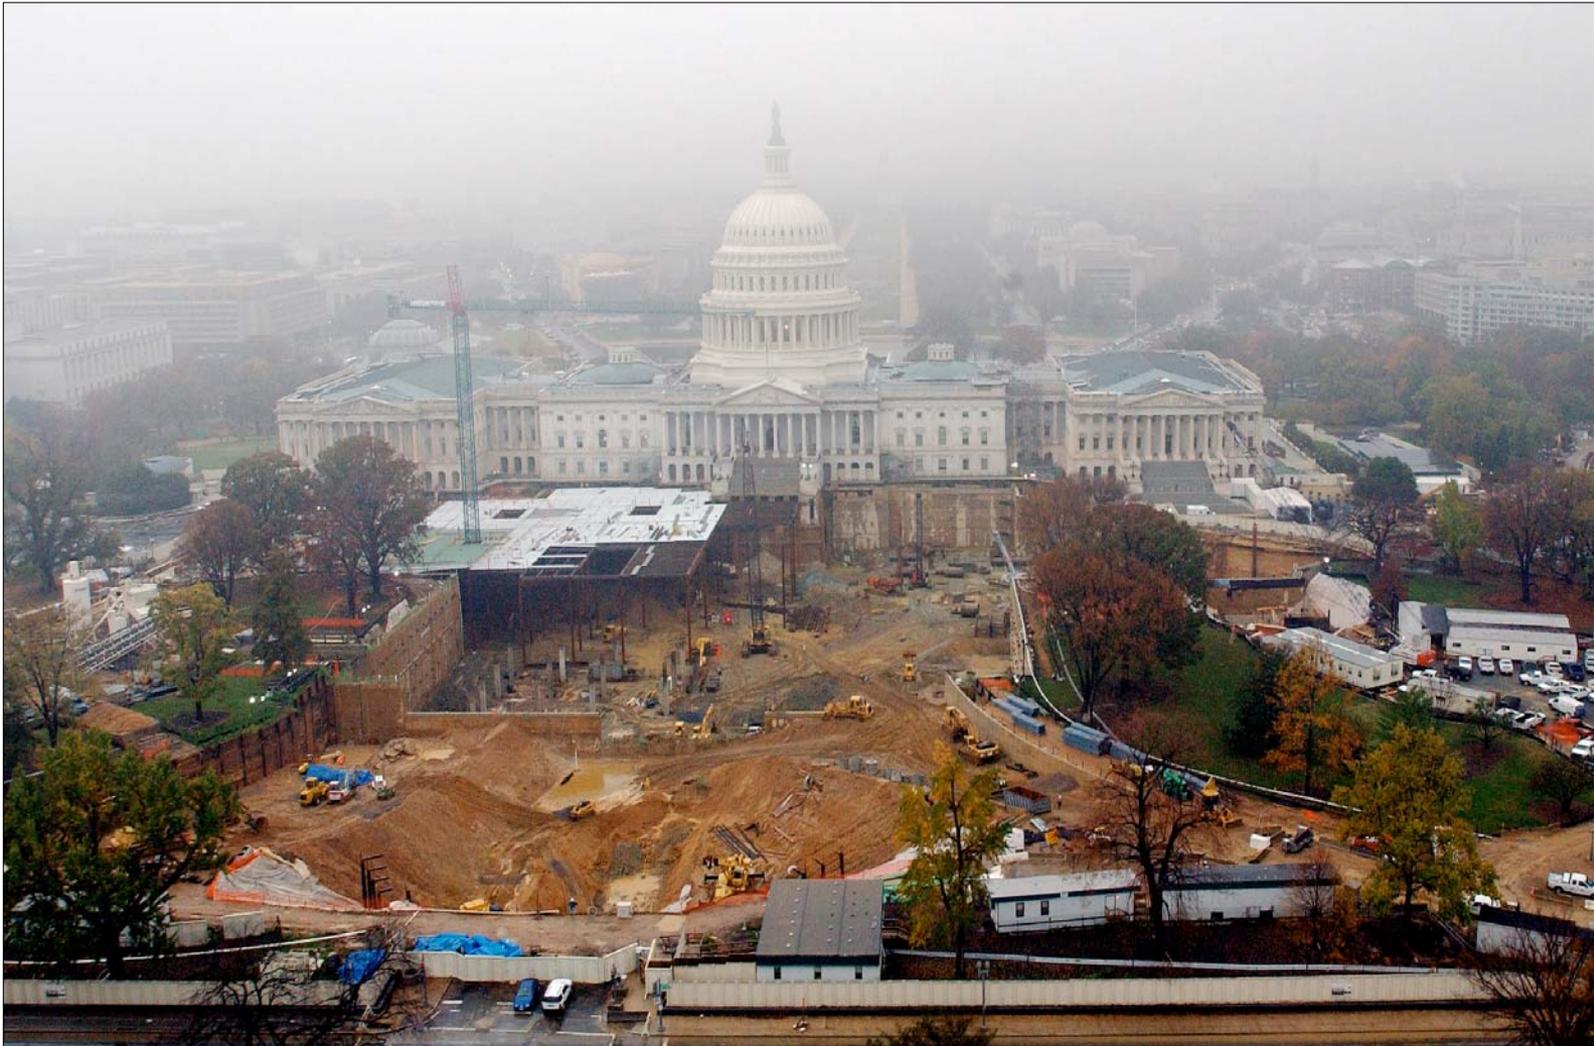
November 6, 2003

Despite a rainy, foggy morning in early November 2003, this view of the the CVC site shows the progress made related to steel erection and installation of the corrugated steel roof decking. Wet weather continued to slow the pace of construction activity throughout the fall of 2003, but significant work did begin below the roof deck. The large opening for one of two grand skylights over the Great Hall of the CVC had been framed and is visible in the center of the photo. Two smaller skylight openings are also visible closer to the Capitol Building.

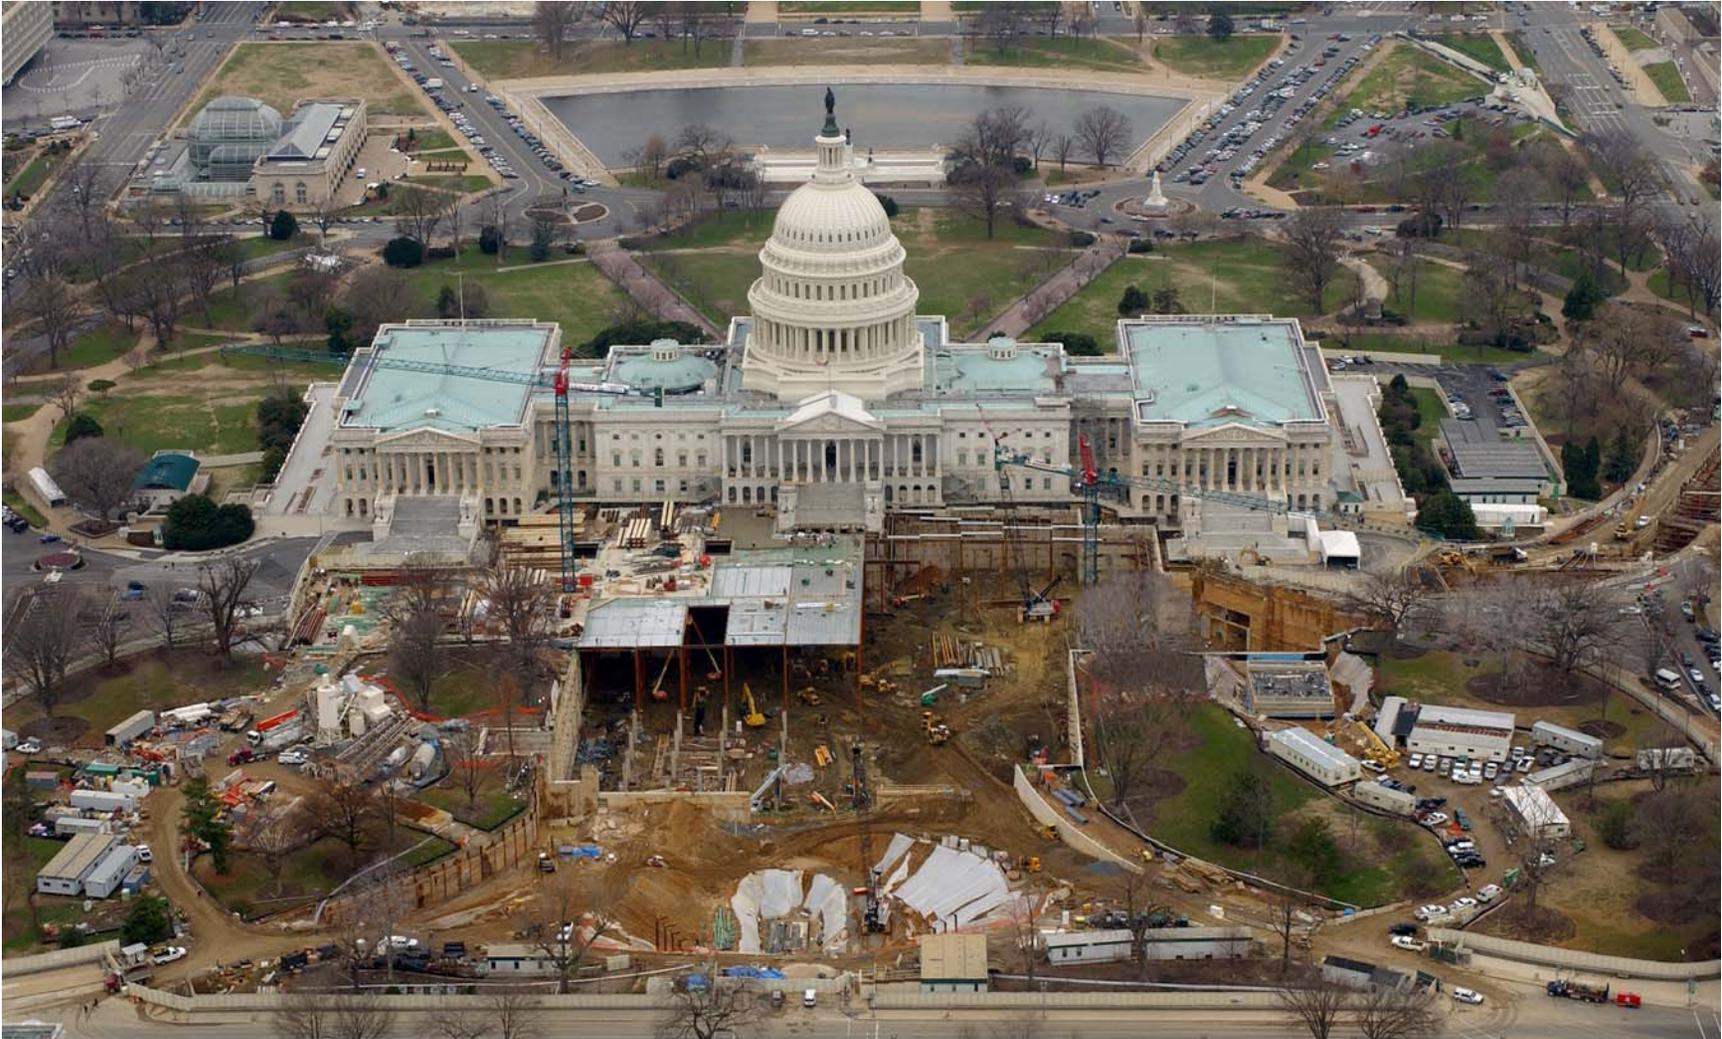
December 18, 2003

By mid-December 2003, the roof decking for the southwest quadrant of the site was in place. Concrete was poured on the roof deck, which soon became home to hundreds of tons of materials being used to form the lower and upper level floor slabs. Steel framework continued to be erected on the north side of the site, which is punctuated with a tower crane that is being used to deliver materials throughout the northern half of the site. Work continued on the slab on grade and for the lower level floor slab. Crews also continued placement of conduit and utilities in all areas of the site. Demolition work continued in the East Front to clear the way for the transition zone between the CVC and the Capitol, including new mechanical systems, stairs, elevators and escalators. Excavation, formwork and concrete placements continued along the length of the new truck tunnel (center right of photo).

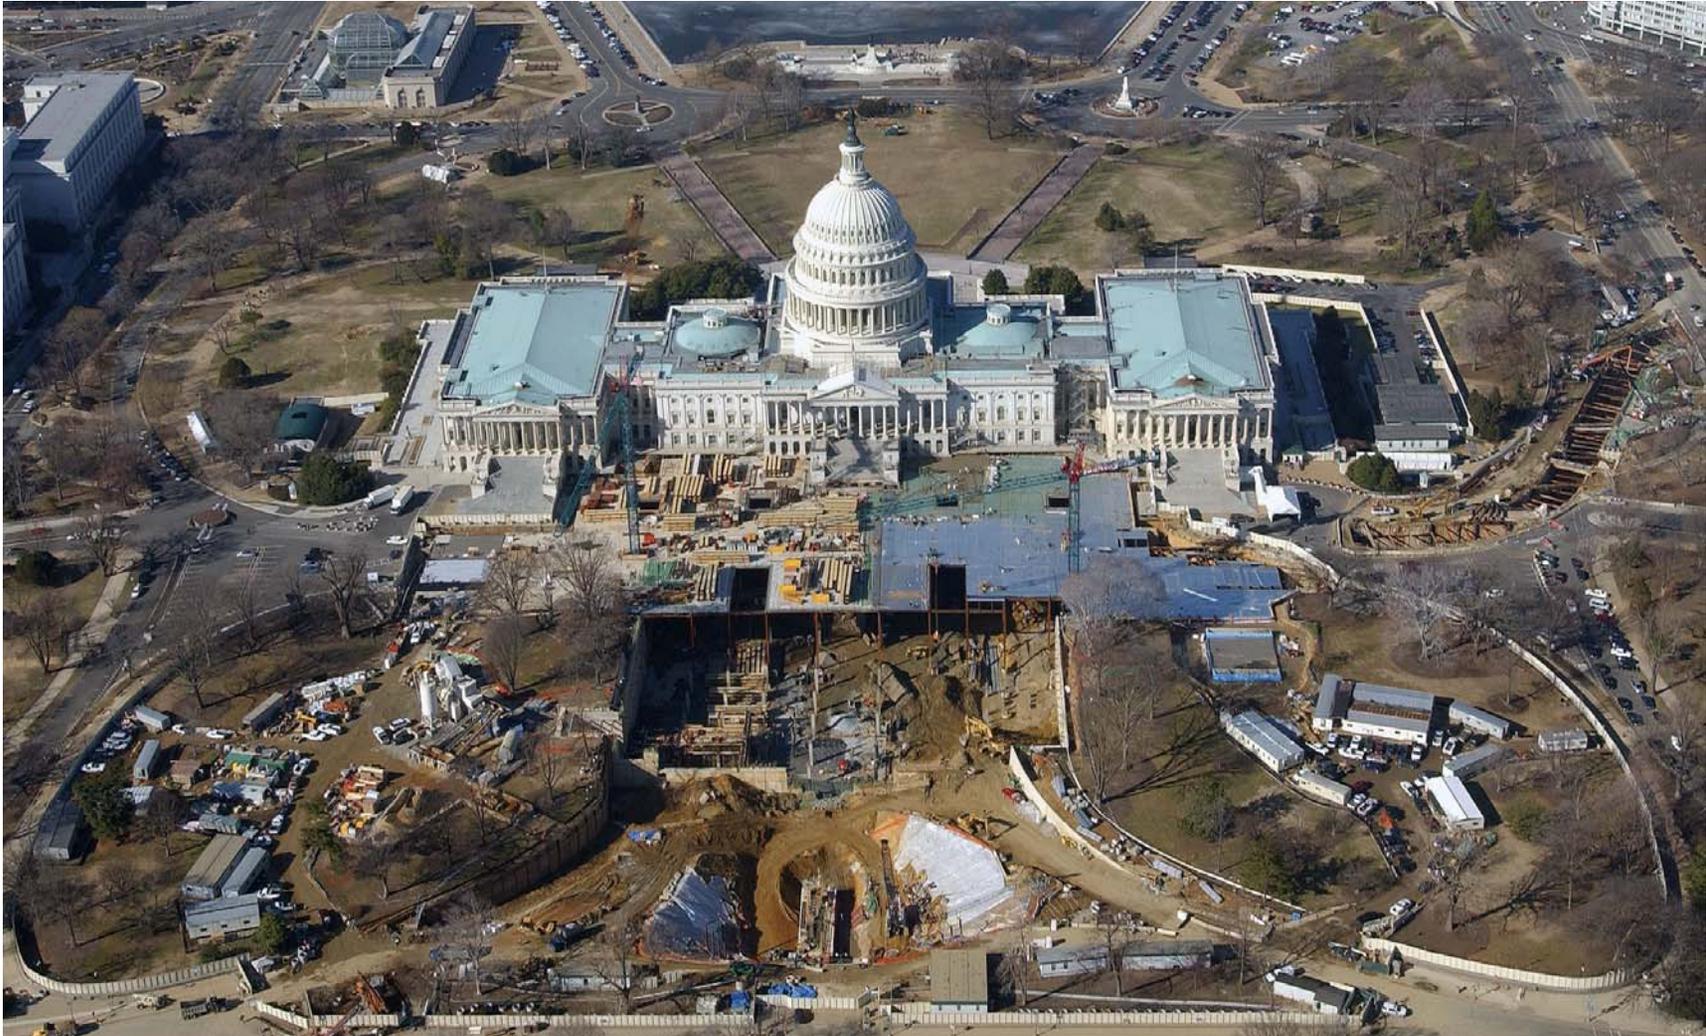
February 13, 2004

By mid-February 2004, the roof decking for the entire western half of the site was in place. Concrete that had already been placed on the roof deck had cured for 28 days to allow crews to begin waterproofing applications. The steel structure was nearly complete and the vehicle access ramp from the eastern half of the site was almost completely removed by this time. Work continued on the slab on grade and for the lower level and upper level floor slabs in the southwest quadrant. Crews also continued placement of conduit and utilities in all areas of the site. Demolition work continued in the East Front to clear the way for the transition zone between the CVC and the Capitol, including new mechanical systems, stairs, elevators and escalators. Excavation, formwork and concrete placements continued along the length of the new truck tunnel (center right of photo).

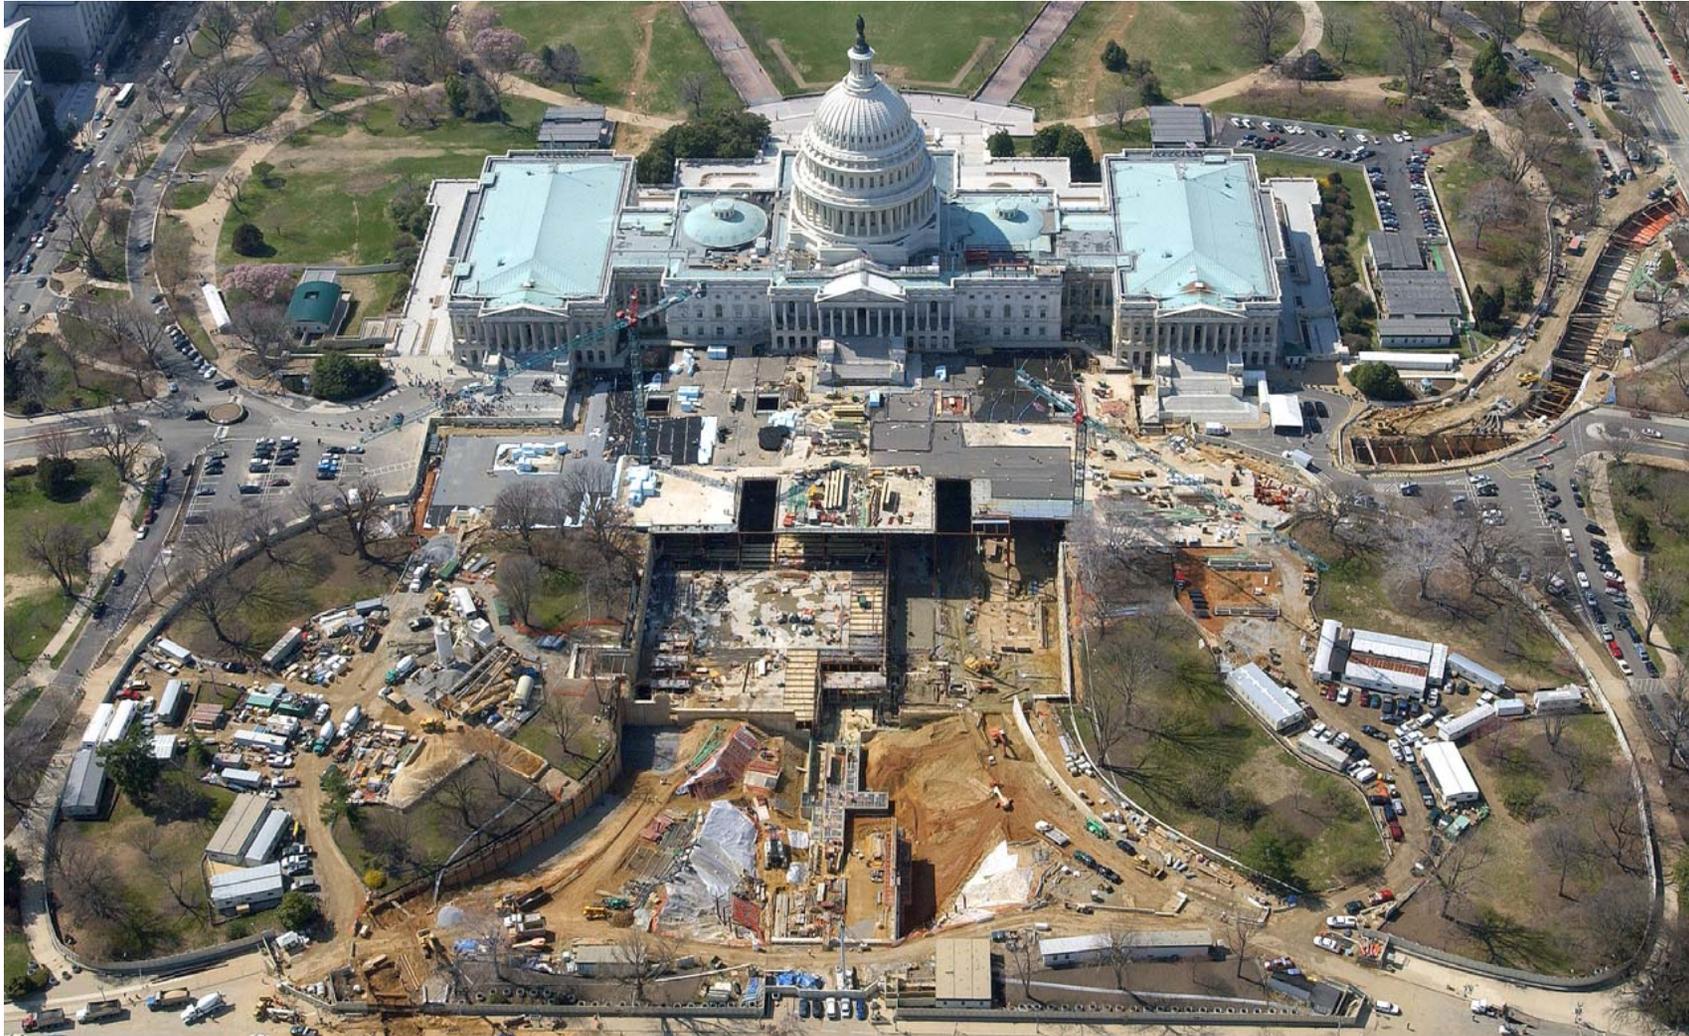
March 25, 2004

By late March 2004, most of the roof decking had been waterproofed and crews began placing a 6-inch gravel bed on top of the waterproofing membrane in preparation for a 6-inch topping slab. Formwork for the lower level floor slab in the southwest end of the side was progressing rapidly and was in place below the Great Hall south skylight. Work continued on the slab on grade throughout the site and for the Library of Congress pedestrian tunnel. Demolition work continued in the East Front to clear the way for the transition zone between the CVC and the Capitol, and two large columns supporting the East Front Steps were removed. In addition, portions of the floor slabs in the East Front had been demolished to clear the way for elevators, stairs and air shafts. Work on the truck tunnel continued and close to 60 percent of the concrete had been placed by this time.
